Evaluation of the San Jacinto Waste Pits Cap Defect

June 2016

Letter Report

Prepared for U.S. EPA, Region 6
Dallas, TX 75202

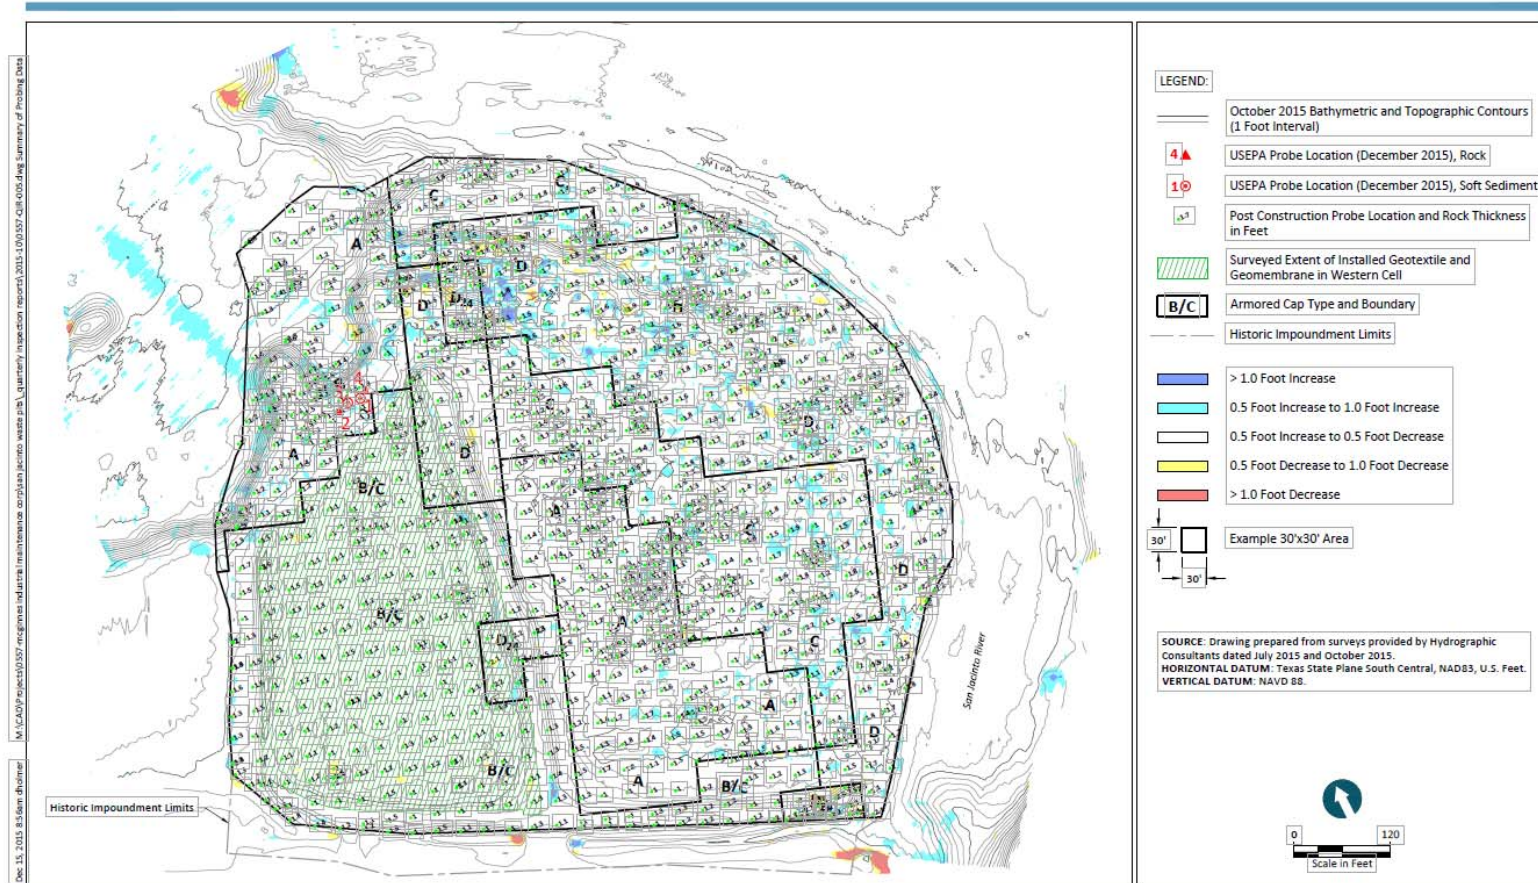
Figure 3. Summary of Probing Data Post TCRA Inspection.

Other activities included the probing and repair of the deficiency by placing a non-woven geotextile in the location of the deficiency (Figures 3, 4, and 5) and placing armor stone over the textile to achieve the required depth of armor.

Probing of the Eastern Cell, after the deficiency area was discovered, resulted in another twelve areas with some deficiencies, so now this is not a single site without rock cover. The twelve defects in the Eastern Cell were much smaller; around one to two square feet each. The dispersed, isolated, small areas of mild slope would suggest that these additional deficient areas could not have been caused by erosion, slope failure or barge strikes. In addition, the presence of the geotextile would also suggest that the defects were not caused by subsidence or bearing capacity issues, leaving construction defects as the only remaining probable explanation. However, it tends to explain how difficult is to build a greater than ninety-nine percent perfect cap with large rocks, the tolerance for imperfections in such a large area is extremely small.

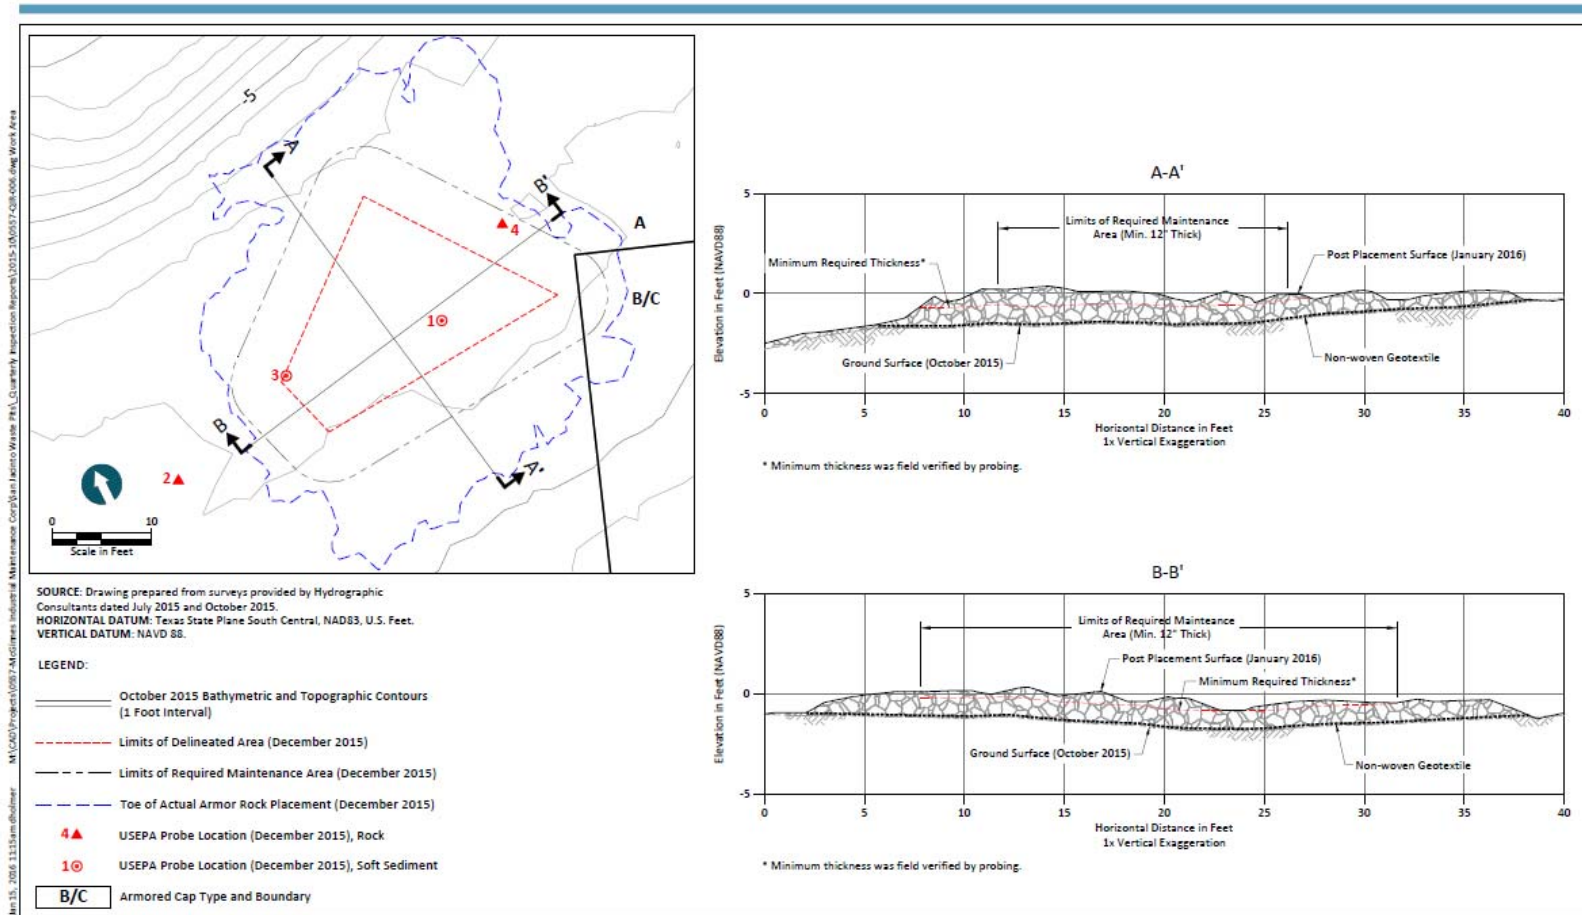
Figure 4. Armor Rock Placement Plan and Cross Sections Post TCRA Inspection

Two potential barge impact conditions can be addressed to understand the potential for a barge to strike the armor cap north of the Western Cell (location shown in Figures 3, 4, and 5) based on flow condition, bottom slope, and water depth. Water depths under normal flow conditions greatly restrict the conditions and locations where a strike may occur. Moderate slope occurs throughout much of the interior of the Eastern Cell and along the northern end of the site, including north of the Western Cell in the Northwestern Area where the cap deficiency was discovered.

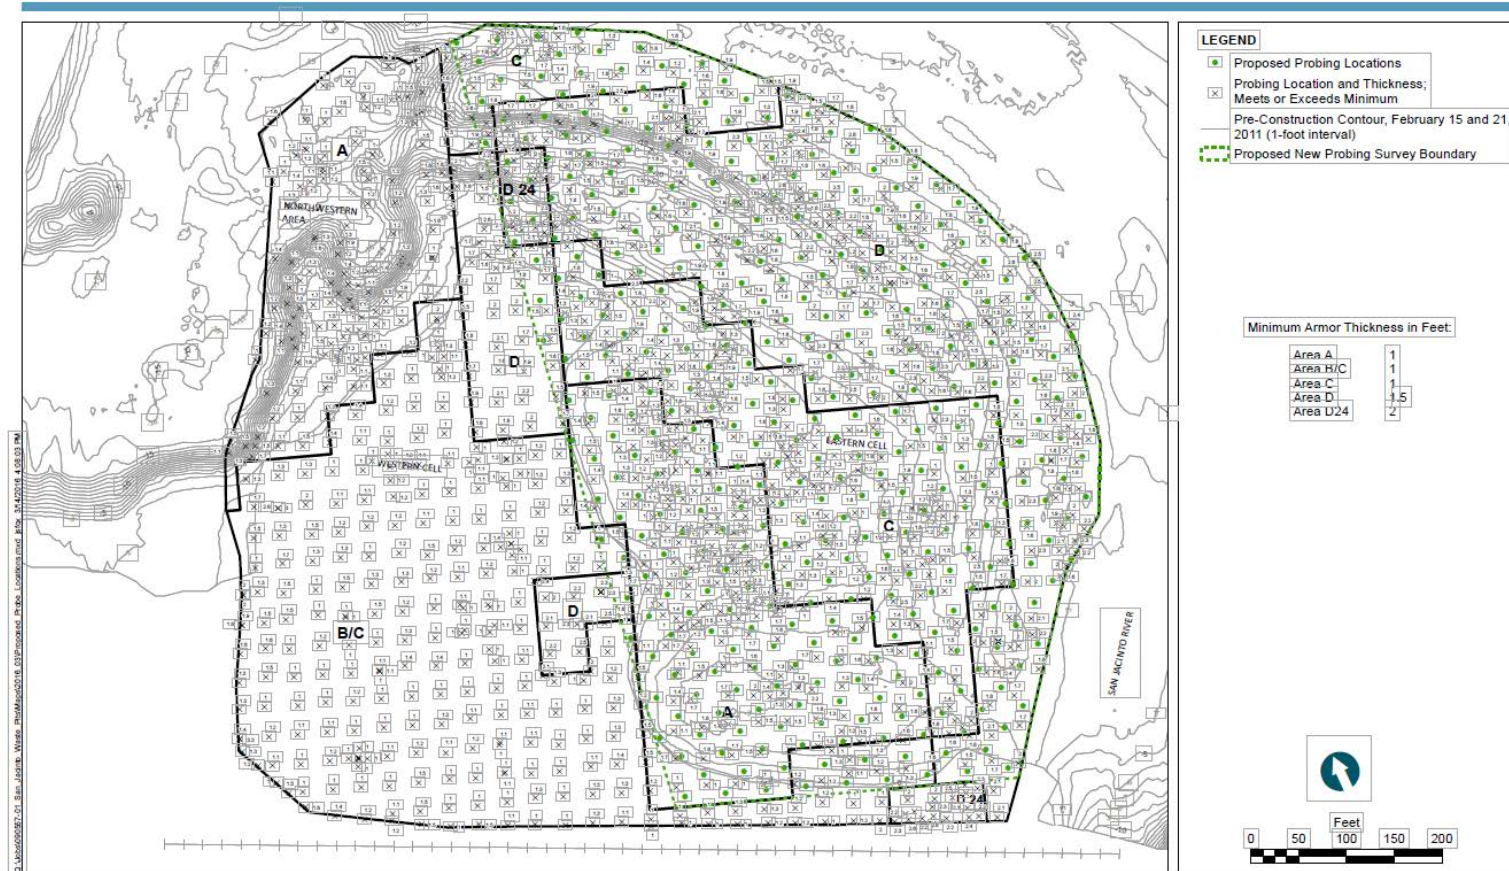
Figure 6. Proposed Supplemental Probing.

been significant ground truthing of the bathymetric data against actual deficiencies. The probing done by the EPA team, the proposed supplemental probing (Figure 6) and the results of those inspections increase the confidence of the integrity of the cap. The surveys, though useful, have not shown the reliability of the probing; the problem with the probing is the lack of coverage of the site. To build the confidence of the cap integrity, more than ninety-five percent of the cap that is probed should be without defects. The results from the Eastern Cell were 12 deficiencies in four hundred probes; that is around ninety seven percent (97%) without significant defect, suggesting that defects are outliers of limited size.

Recommendations include supplemental probing like the one performed in the Eastern Cell; the goal is to reduce the number of deficiencies. Probing should continue to the Western Cell with the same density as what was performed in the Eastern Cell (200-250), and the finally to the Northwestern Area. Here is where it gets trickier; this area requires the greatest density of manual probing since it is the steepest and does not have a geotextile or geomembrane. Manual probing in the order of 300-400 is not out of the question based on the potential for deficiencies in this area due to construction and post-construction conditions.

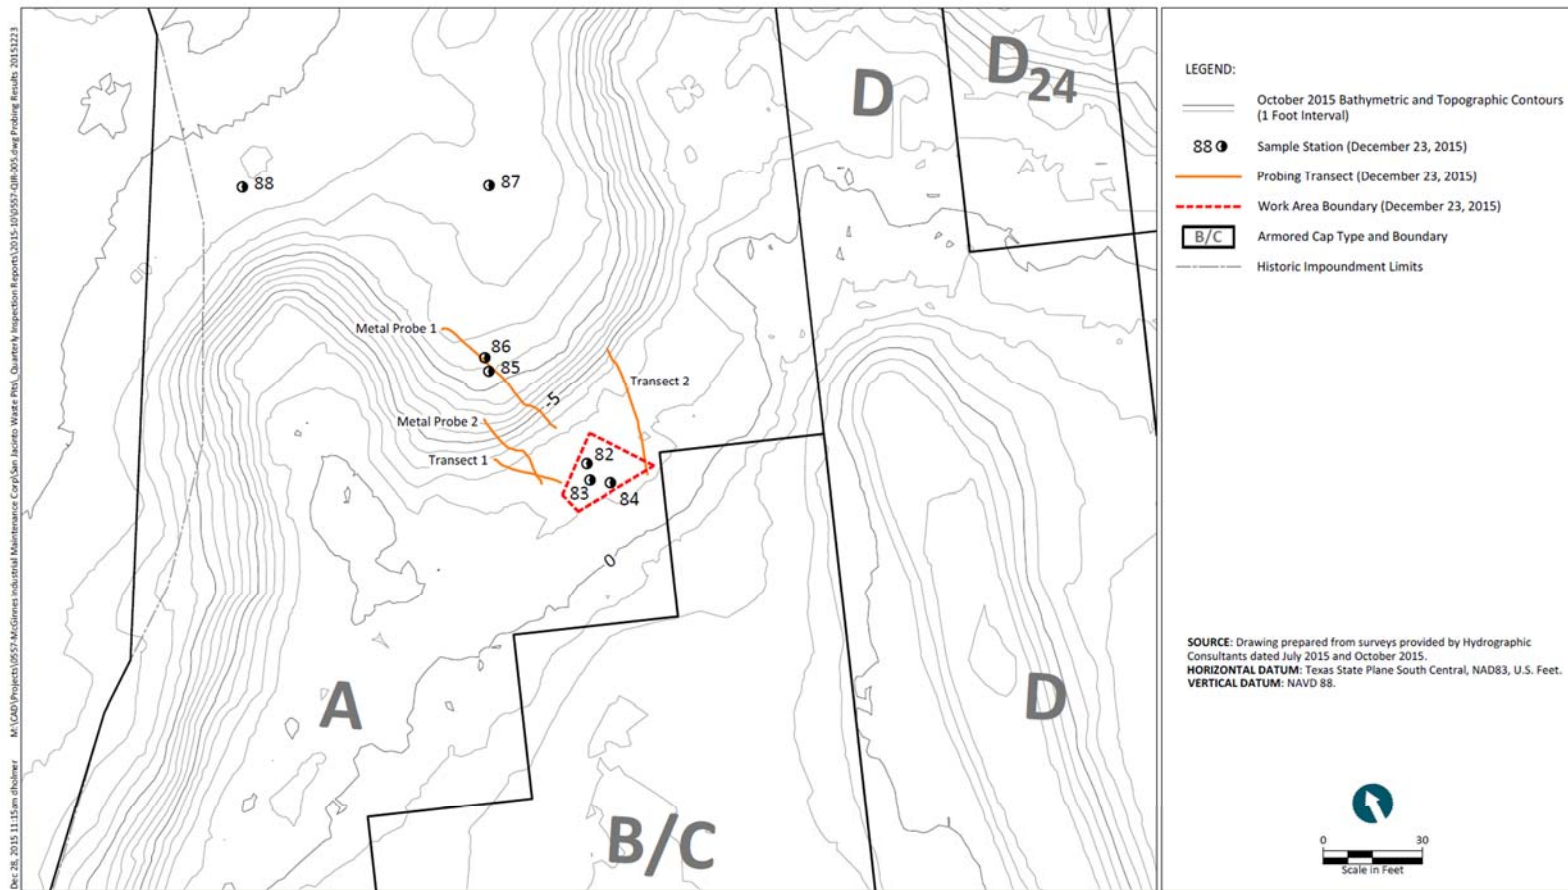
Figure 8. Probing and Sample Collection as part of Maintenance and Repair of the Deficiency Area of the SJRWP Armor Cap.

Figure 8 shows the probing transects and samples collected as part of the assessment of the cap deficiency in December 2015. Figures 9 and 10 show the level of contaminant in the three sediment samples collected from the cap deficiency. Figure 9 is from the exposed sediment, the sample was split with EPA and documented in the report 05_San Jacinto RIFS OS Data Validation for December 2015 Split Sampling, a letter report.

The levels of the three samples collected from within the cap deficiency zone vary significantly; two are around 40,000 ng/kg and one is nearly an order of magnitude less (8180 ng/kg).

The levels of the two samples (SJNE085 and SJNE 086) from the northwest toe of the cap's sloped area near the cap deficiency area are shown in Figure 9. The levels are 500 times lower than the two highest values at the impacted zone and 100 times lower than the lowest value from the impacted zone.

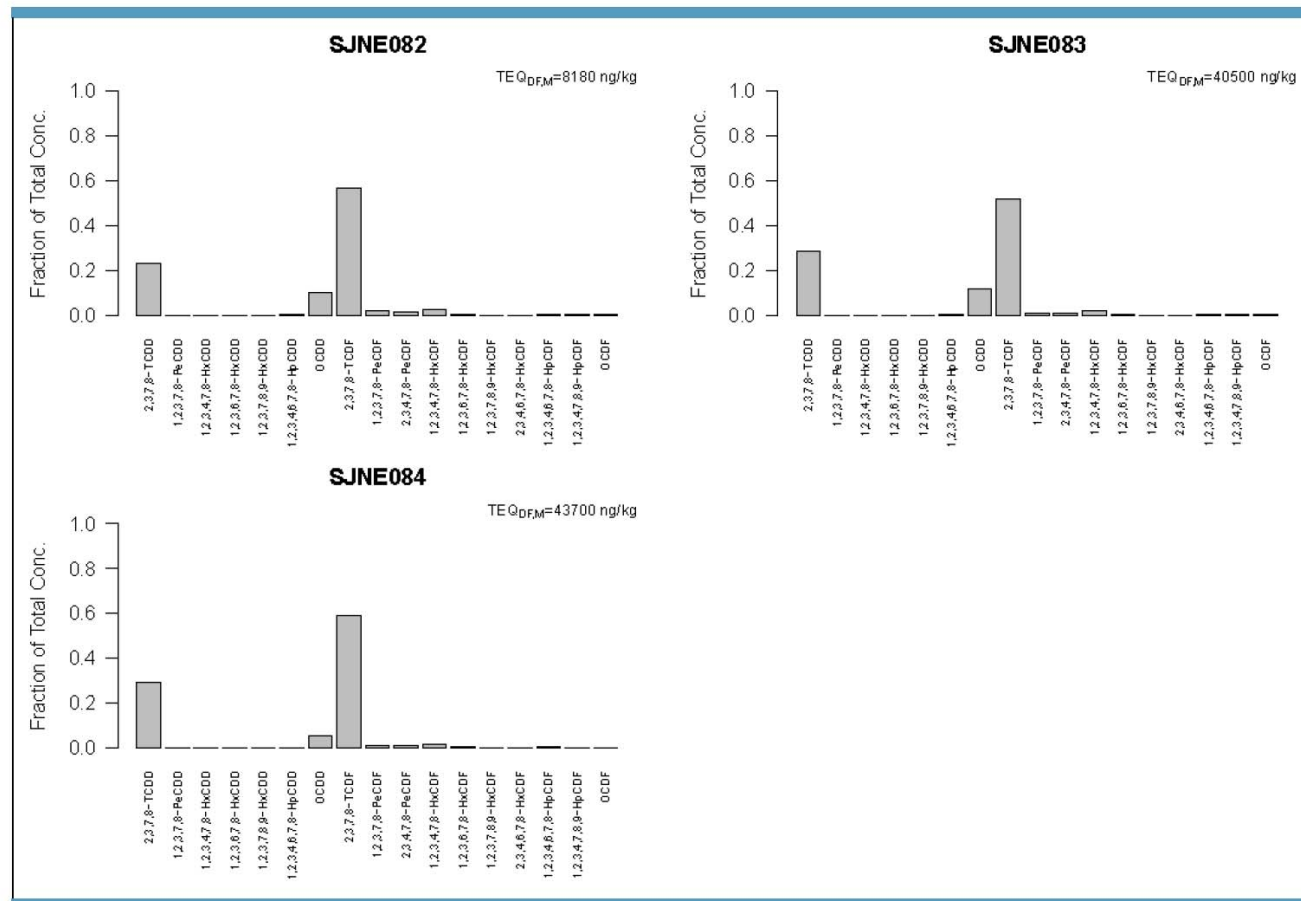
Figure 9. Dioxin and Furan Fingerprints for 2015 Sediment Samples Collected from Within the Delineated Area.

Comparison of Figure 12 with Figures 9 and 10 shows that the fingerprint from the sediments collected in the deficient area is close to the EM2 model, while the data from the sites outside the exposed area follow the EM1 model. If sediment from the deficient area was released the impacted sites would exhibit a form of the EM2 model (fingerprint), one can say that there is a slight contribution by the short peak of TCDF, so most of the sediment from the toe and outside areas receive most of the loadings from other areas beside the SJRWP. In addition, the samples from the deficient area show evidence of deposition of sediment from outside the SJRWP due to presence of higher distribution of OCDD than in the EM2 model. The presence of deposition in the deficient area would indicate the long-term presence of the defect, the stability of sediment at the defect, and no significant release of contaminants from the deficient area.

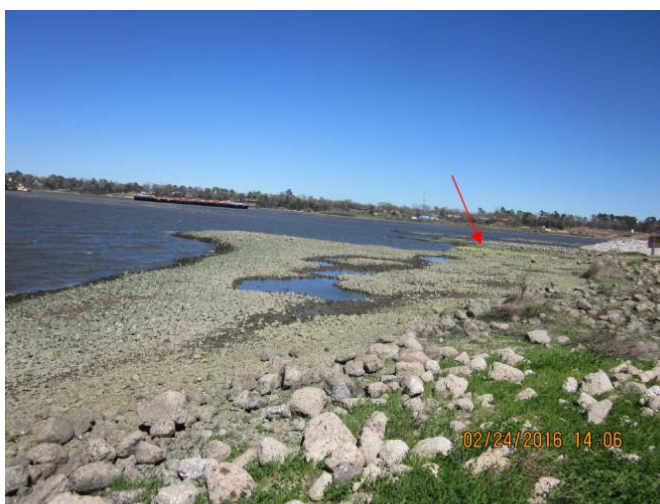
Figure A5. Site investigation/maintenance area after repairs.

ridge/rocks on that area do not show any impact or disturbance (see Figures A5 and A6).

The other potential strike as shown in Figure A9 is from the west side, again the ridge/rocks on that side (see Figures A5 and A6) show no disturbance.

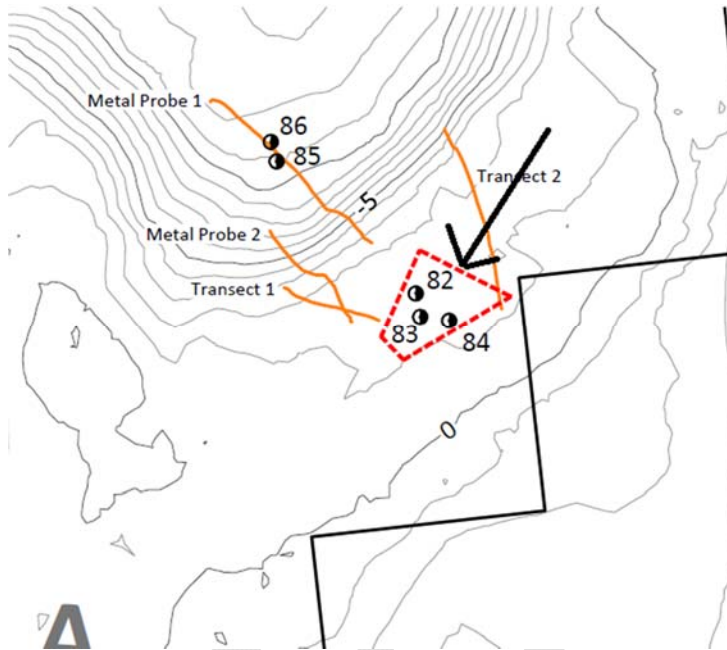
Figure A8. Strike direction.

Looking at the area of impact/deficiency as delineated in Figure A7 shows that angle of impact from a barge/tug strike should have occurred from the northwest (where sample 82 was collected, toward sample 83, see Figure A8). That follows the wedge that a tug would have created. The difficulty with that strike is that there is a ridge on that side of the deficient area as shown in Figures A2-A6, and that

So based on the angles, the lack of impact around the surrounding areas where the approach would have occurred, and the lack of depression in the deficiency area we can say that a barge/tug strike was very unlikely.

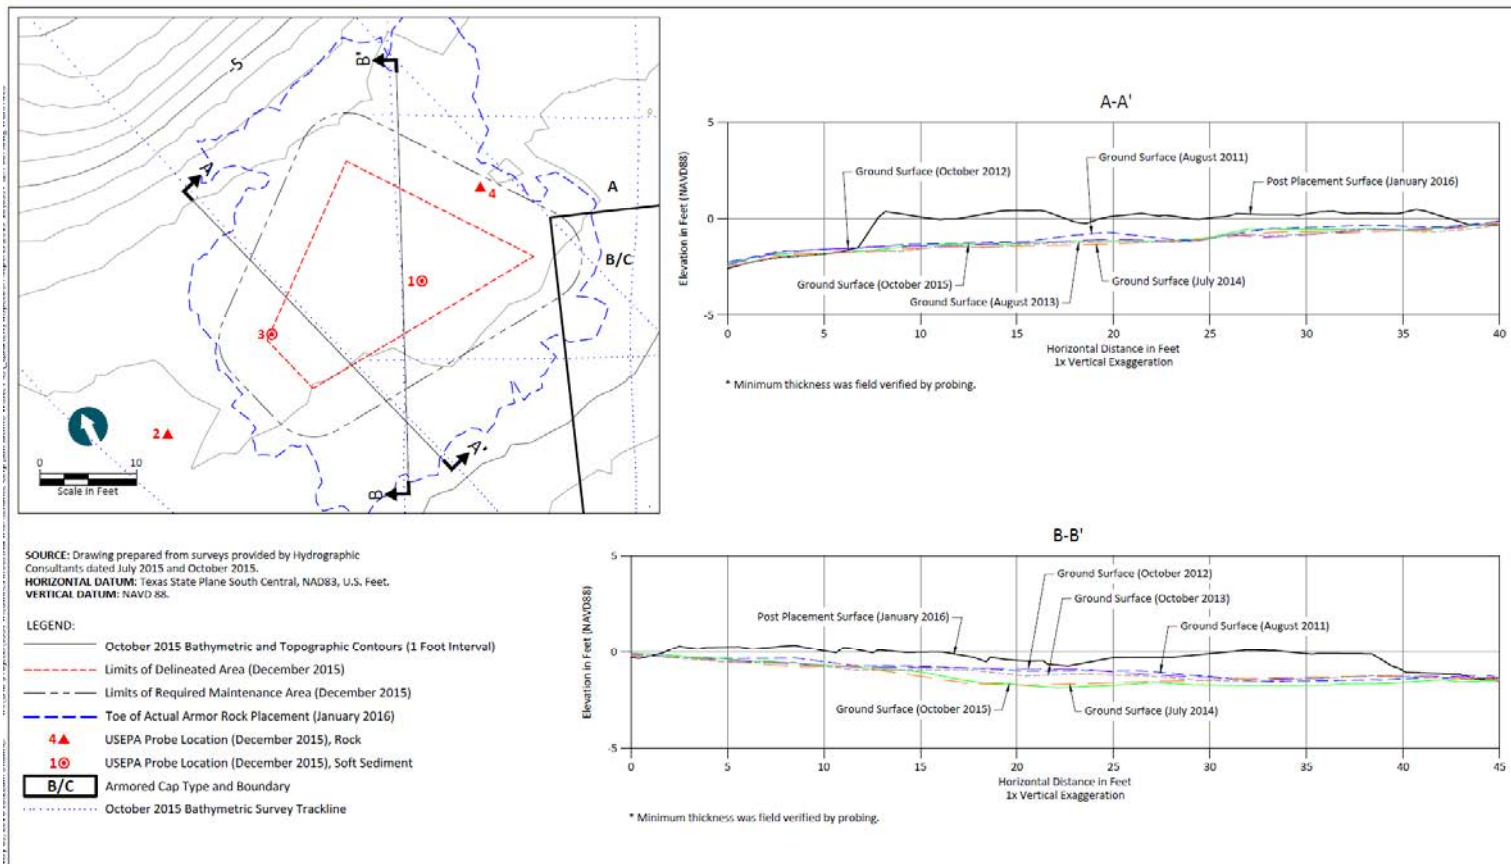
Figure B1. Bathymetric and topographic surveys for the defect area.

Appendix B shows that the area of the defect has been changing in elevation since at least 2013 and maybe even 2012. The discussion in Appendix B was after communication with the repair team and there wiliness to provide us with ground surveys for the deficient area for the last six years. The data leads us to belief that the defect area was caused by sinking of the cap over time due to either improper filter/support layer under the rock cap or unusual decomposition of organic matter under the area.

Figure B1 shows the area where the EPA dive team found the deficiency area and was later repaired. The Figure also shows ground surveys from 2011 till 2015, an eastern transect A-A and a northwestern transect B-B, and the probing locations that defined the defect area. The B-B transect clearly shows that part of the defect area was showing a dip in elevation or subsidence since 2013 and maybe even 2012. Figure B2 shows the elevations for transect B-B in more detail; the subsidence starts in 2013 (at least two inches as compared to 2012) by 2014 the subsidence is at least 8-12 inches. The fact that we see a gradual loss or dip in elevation points to subsidence rather than impact. The cause of the subsidence is probably due to lack of support of the larger rocks in the upper cap layer. This area does not have a geotextile under the cap, so if the filter layer under the cap was not properly placed or if the mud underneath exhibit decay or uneven consolidation, then the rocks would begin to sink causing subsidence of the area. In the future it would be very useful to collect bathymetry and ground surveys prior to repairing the cap due to either scheduled maintenance or probing. The collected bathymetry or surveys would be extremely useful in understanding the cause of an event that resulted in a repair or assessment.

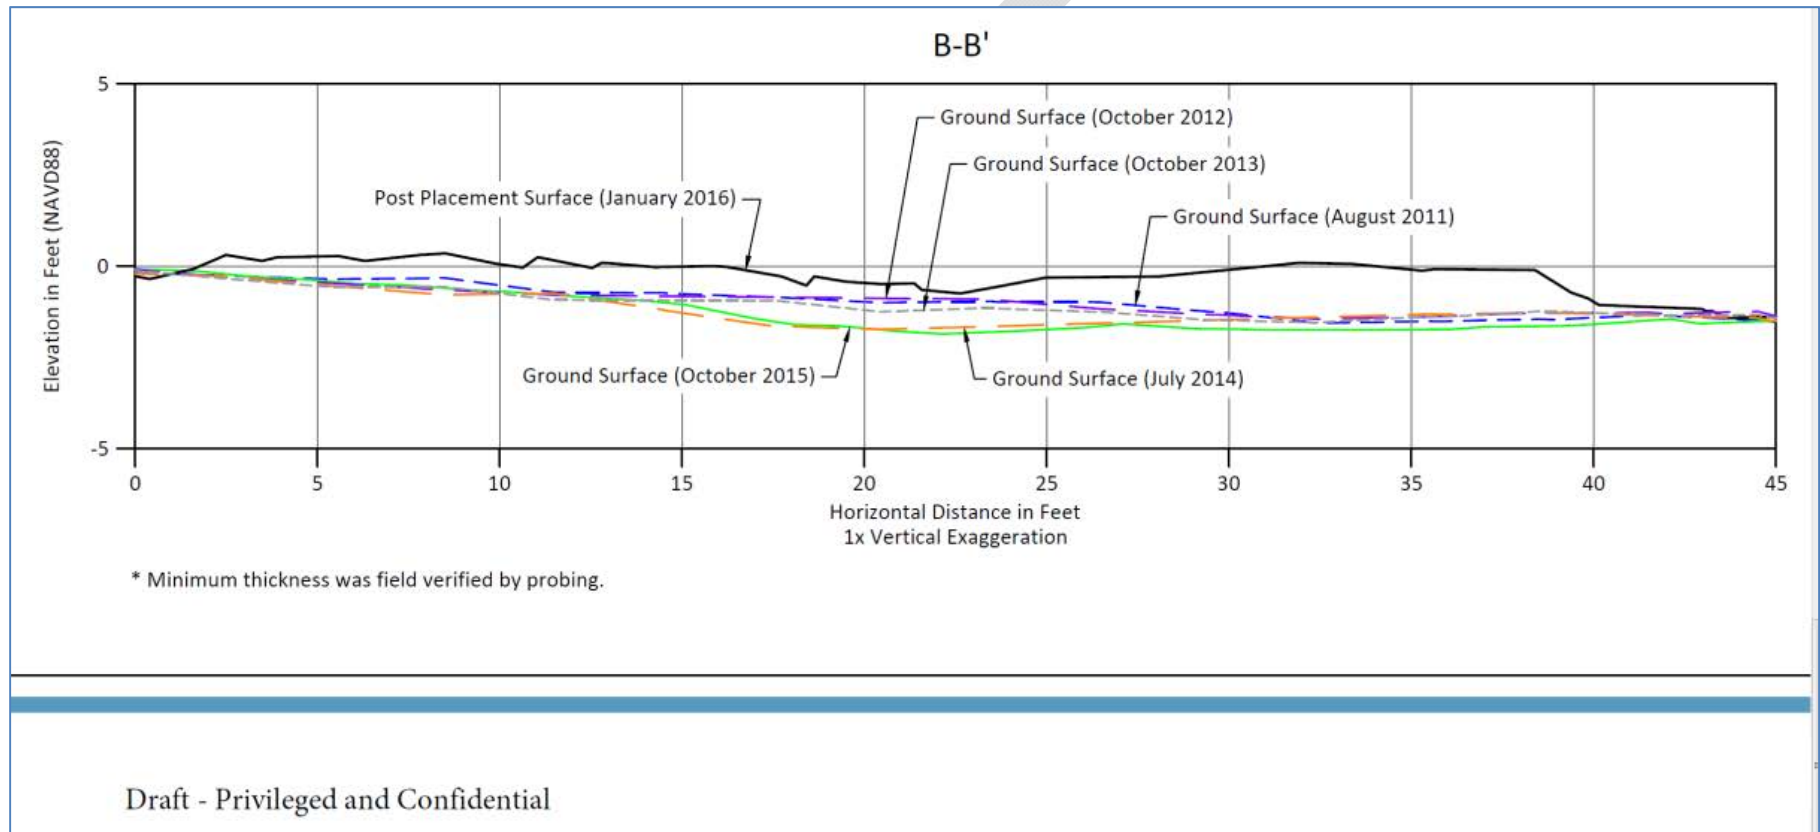
Figure B2. Ground survey at the defect area: transect B-B.

Based on all the above the most likely cause of the defect is subsidence due to inadequate construction controls.
